RE: First Quarter 2013 Groundwater and LNAPL Elevation Measurements and LNAPL Recovery
Results, Former Texaco Sunburst Works Refinery, Sunburst, Montana

FIRST QUARTER 2013 RECOVERY RESULTS LETTER

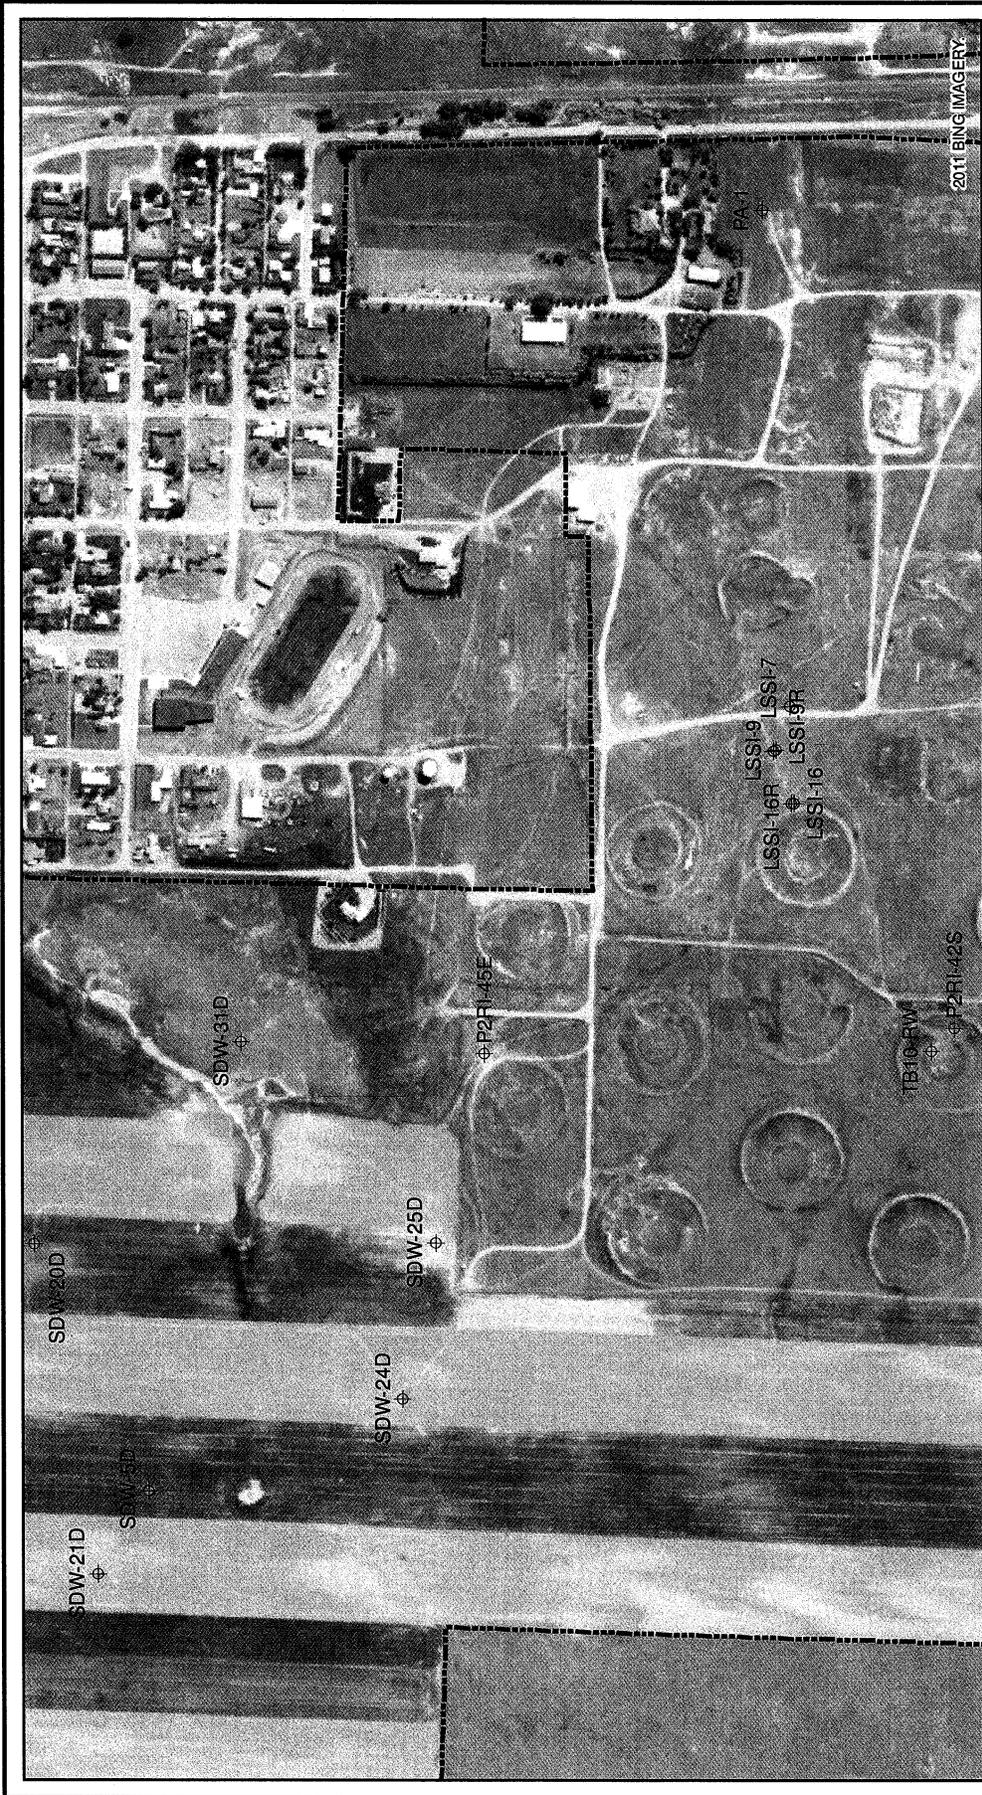
FIGURE 1	
FLUID LEVEL GAUGING LOCATIONS	
FORMER TEXACO SUNBURST WORKS REFINERY SUNBURST, MONTANA

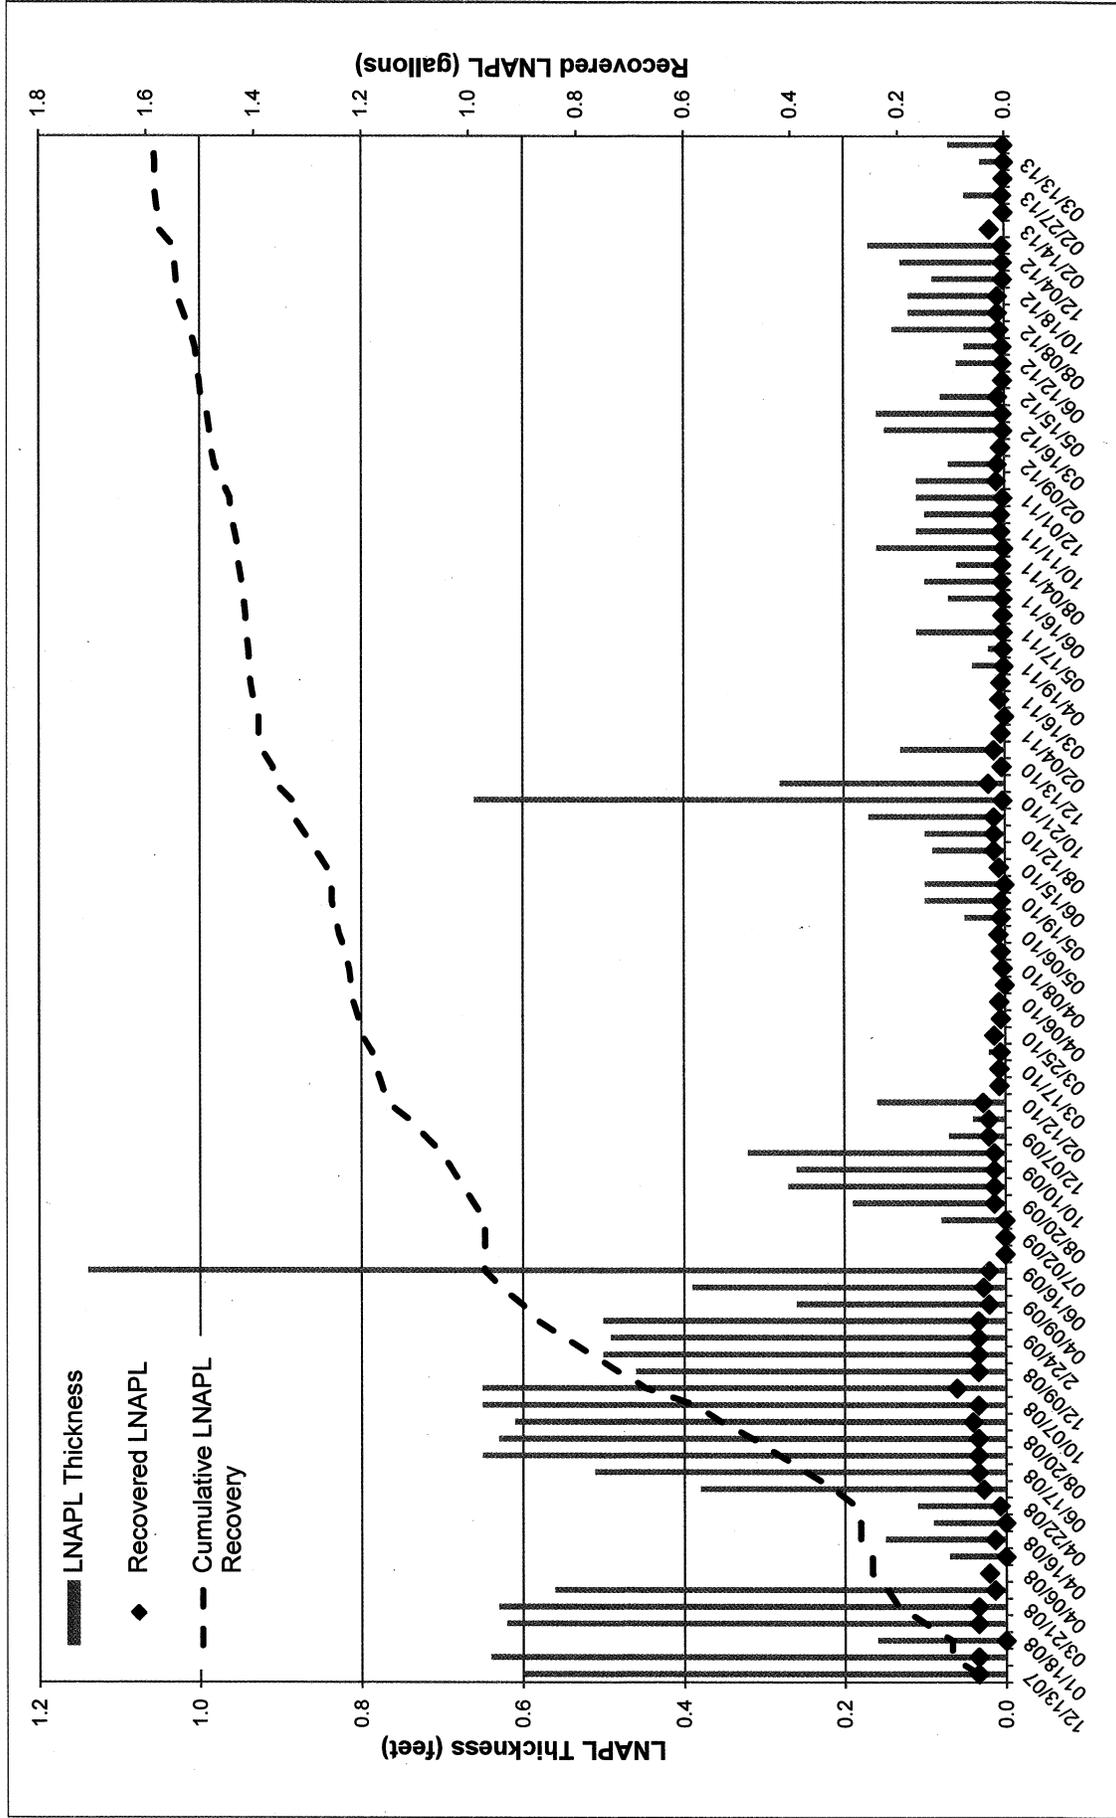
FIGURE 2. RECOVERED LNAPL AND LNAPL THICKNESS SUMMARY, LSSI-9
FORMER TEXACO SUNBURST WORKS REFINERY, SUNBURST, MONTANA

The results of all LNAPL recovery activities completed at the Facility during the first quarter of 2013 are summarized in Table 1. Figures 2 through 9 provide a summary of LNAPL thickness, and the cumulative amount of LNAPL recovered to date for locations LSSI-9, LSSI-9R, LSSI-16, LSSI-16R, PA-1, SDW-20D, SDW-24D, and SDW-31D. Figure 10 provides a Facility-wide historical LNAPL recovery summary based on each month's LNAPL recovery total since December 2007. Facility-wide, CEMC has recovered approximately 898 gallons of LNAPL (with some ancillary groundwater) since December 2007.

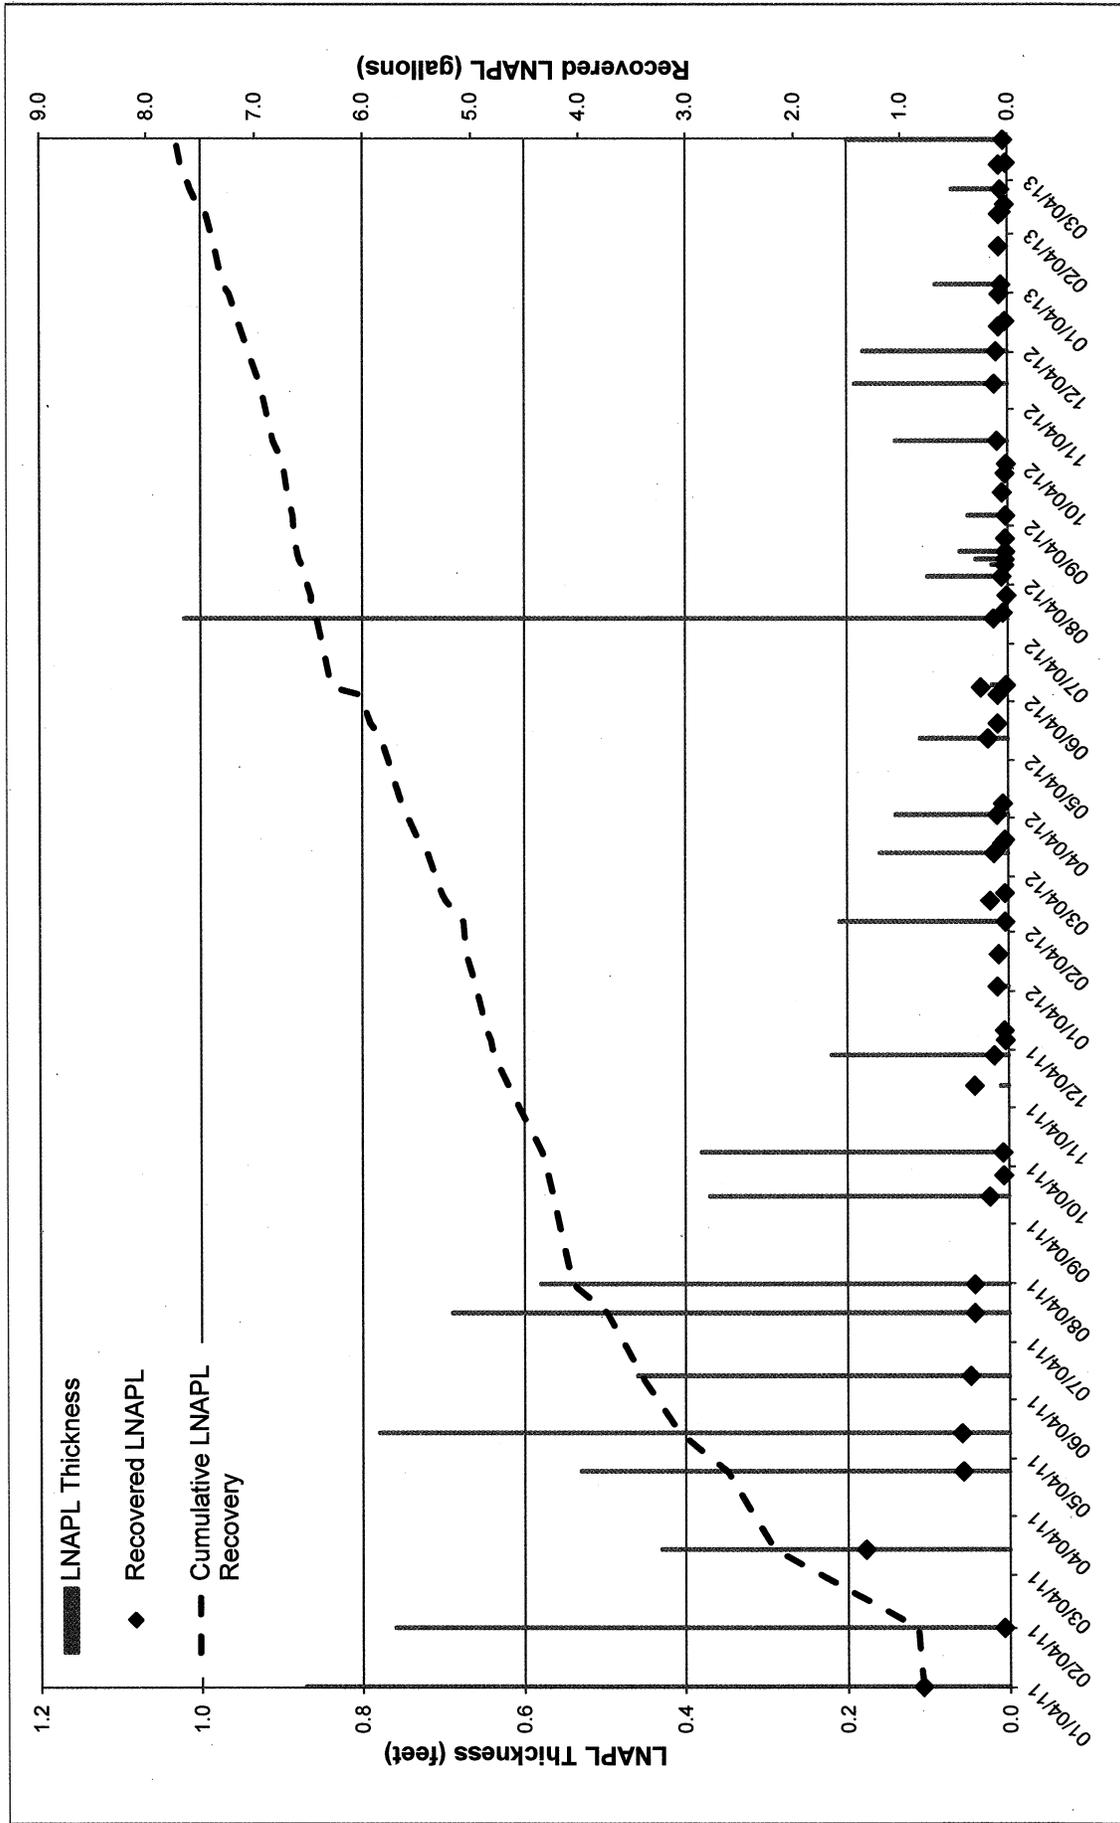
FIGURE 3. RECOVERED LNAPL AND LNAPL THICKNESS SUMMARY, LSSI-9R
 FORMER TEXACO SUNBURST WORKS REFINERY, SUNBURST, MONTANA

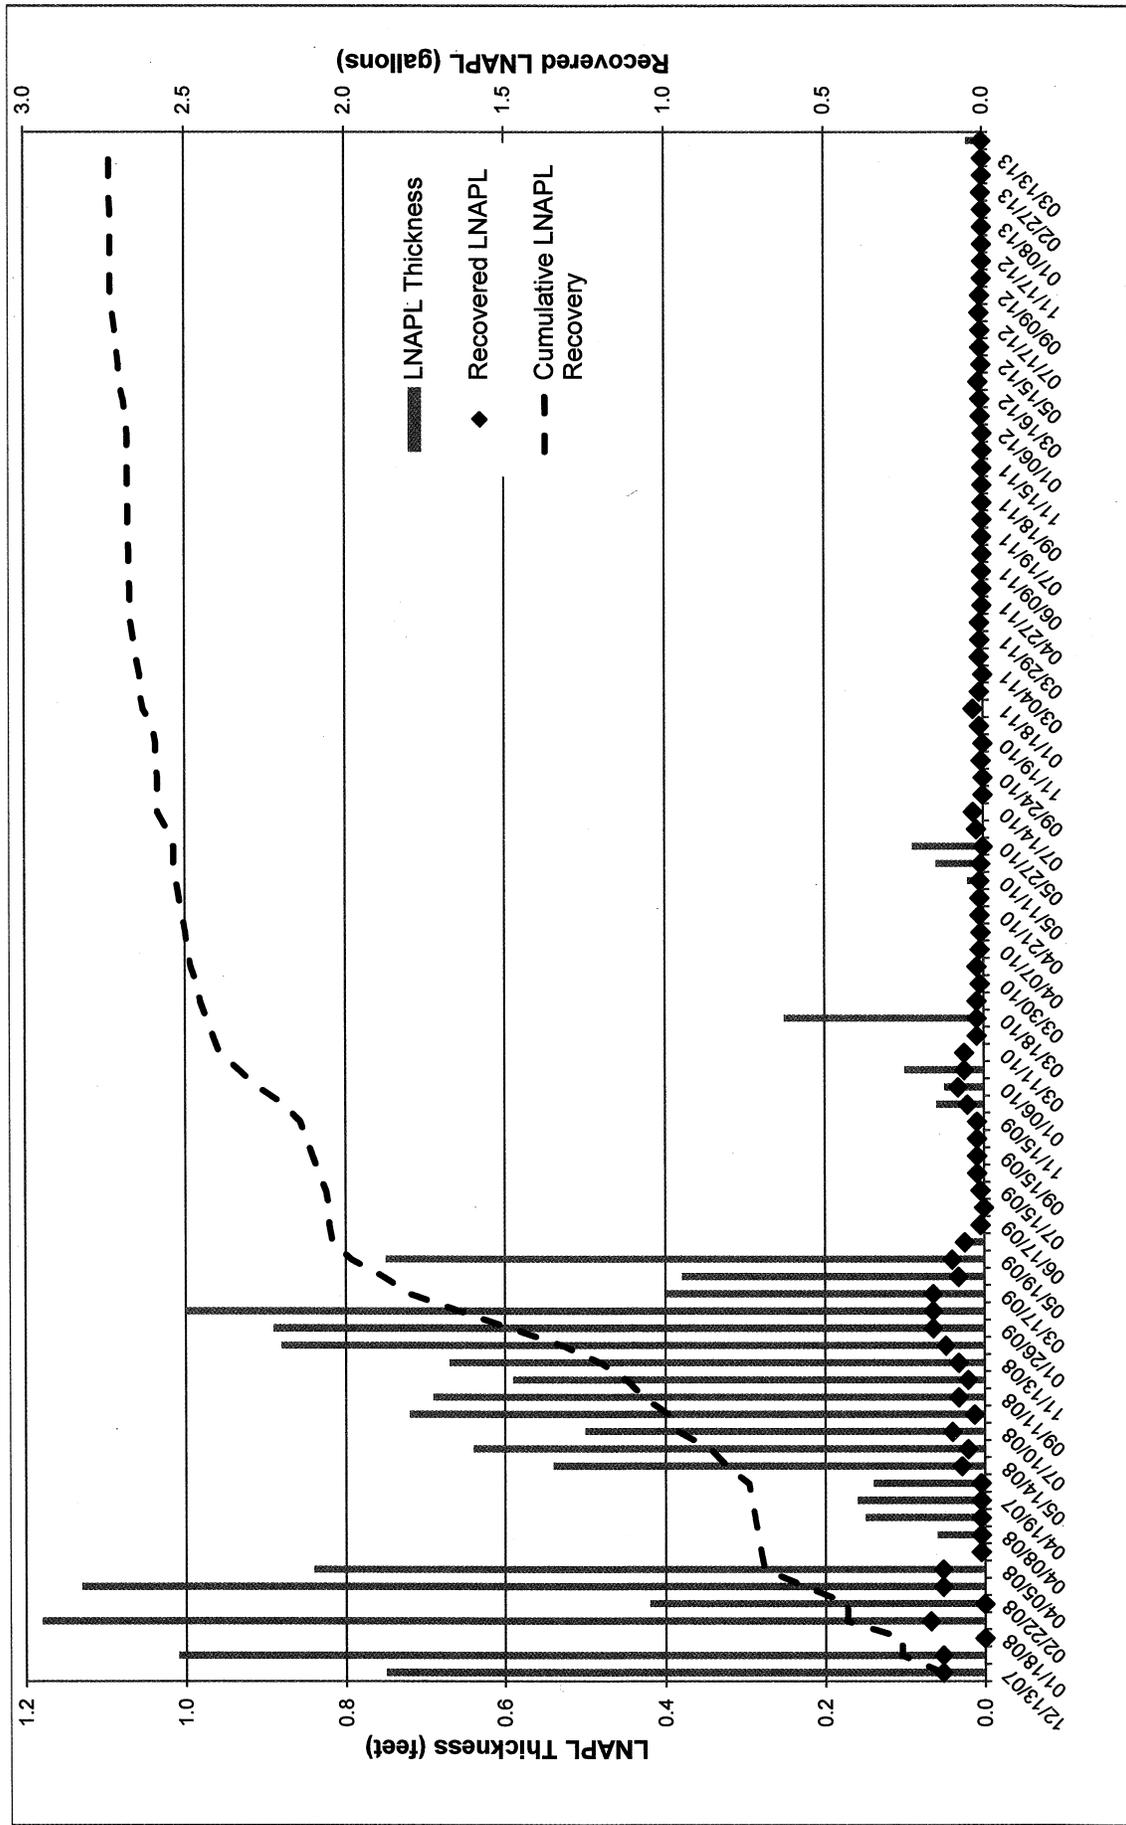
FIGURE 4. RECOVERED LNAPL AND LNAPL THICKNESS SUMMARY, LSSI-16
 FORMER TEXACO SUNBURST WORKS REFINERY, SUNBURST, MONTANA

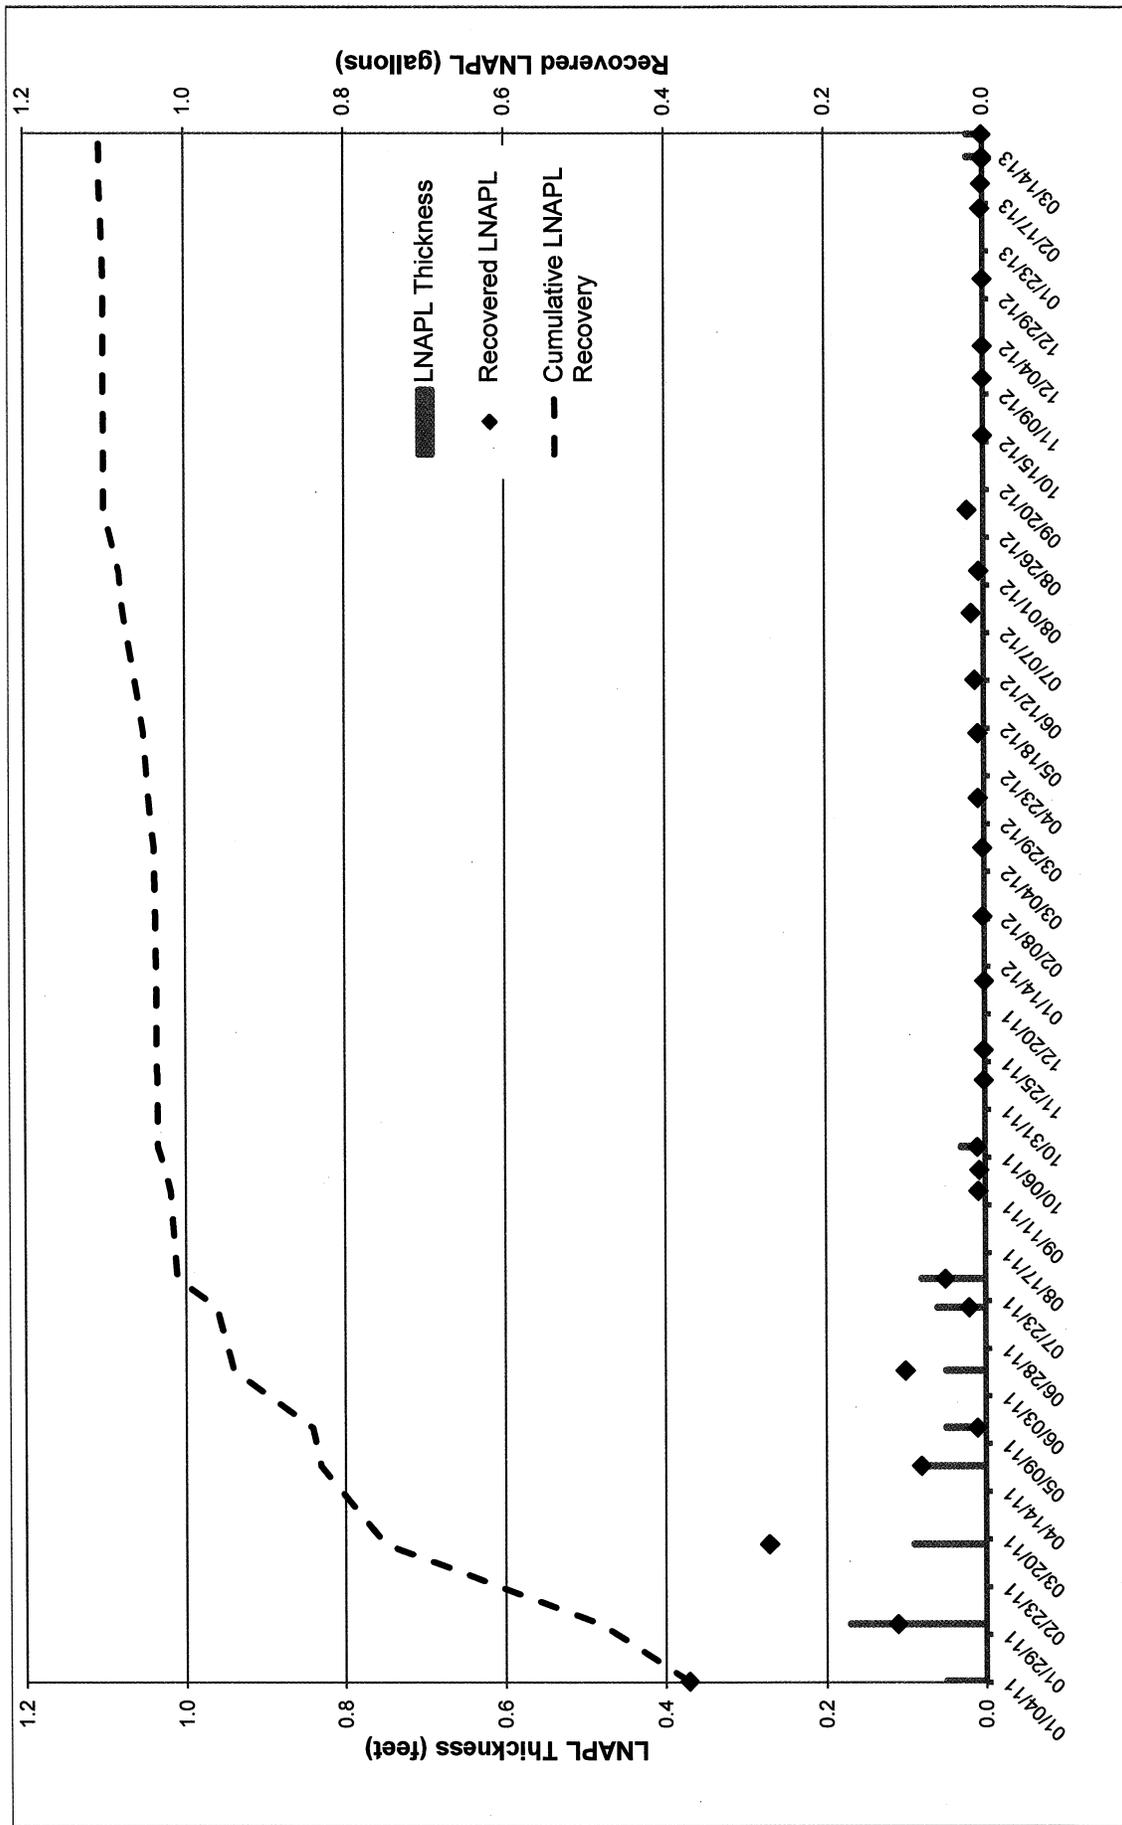
FIGURE 5. RECOVERED LNAPL AND LNAPL THICKNESS SUMMARY, LSSI-16R
 FORMER TEXACO SUNBURST WORKS REFINERY, SUNBURST, MONTANA

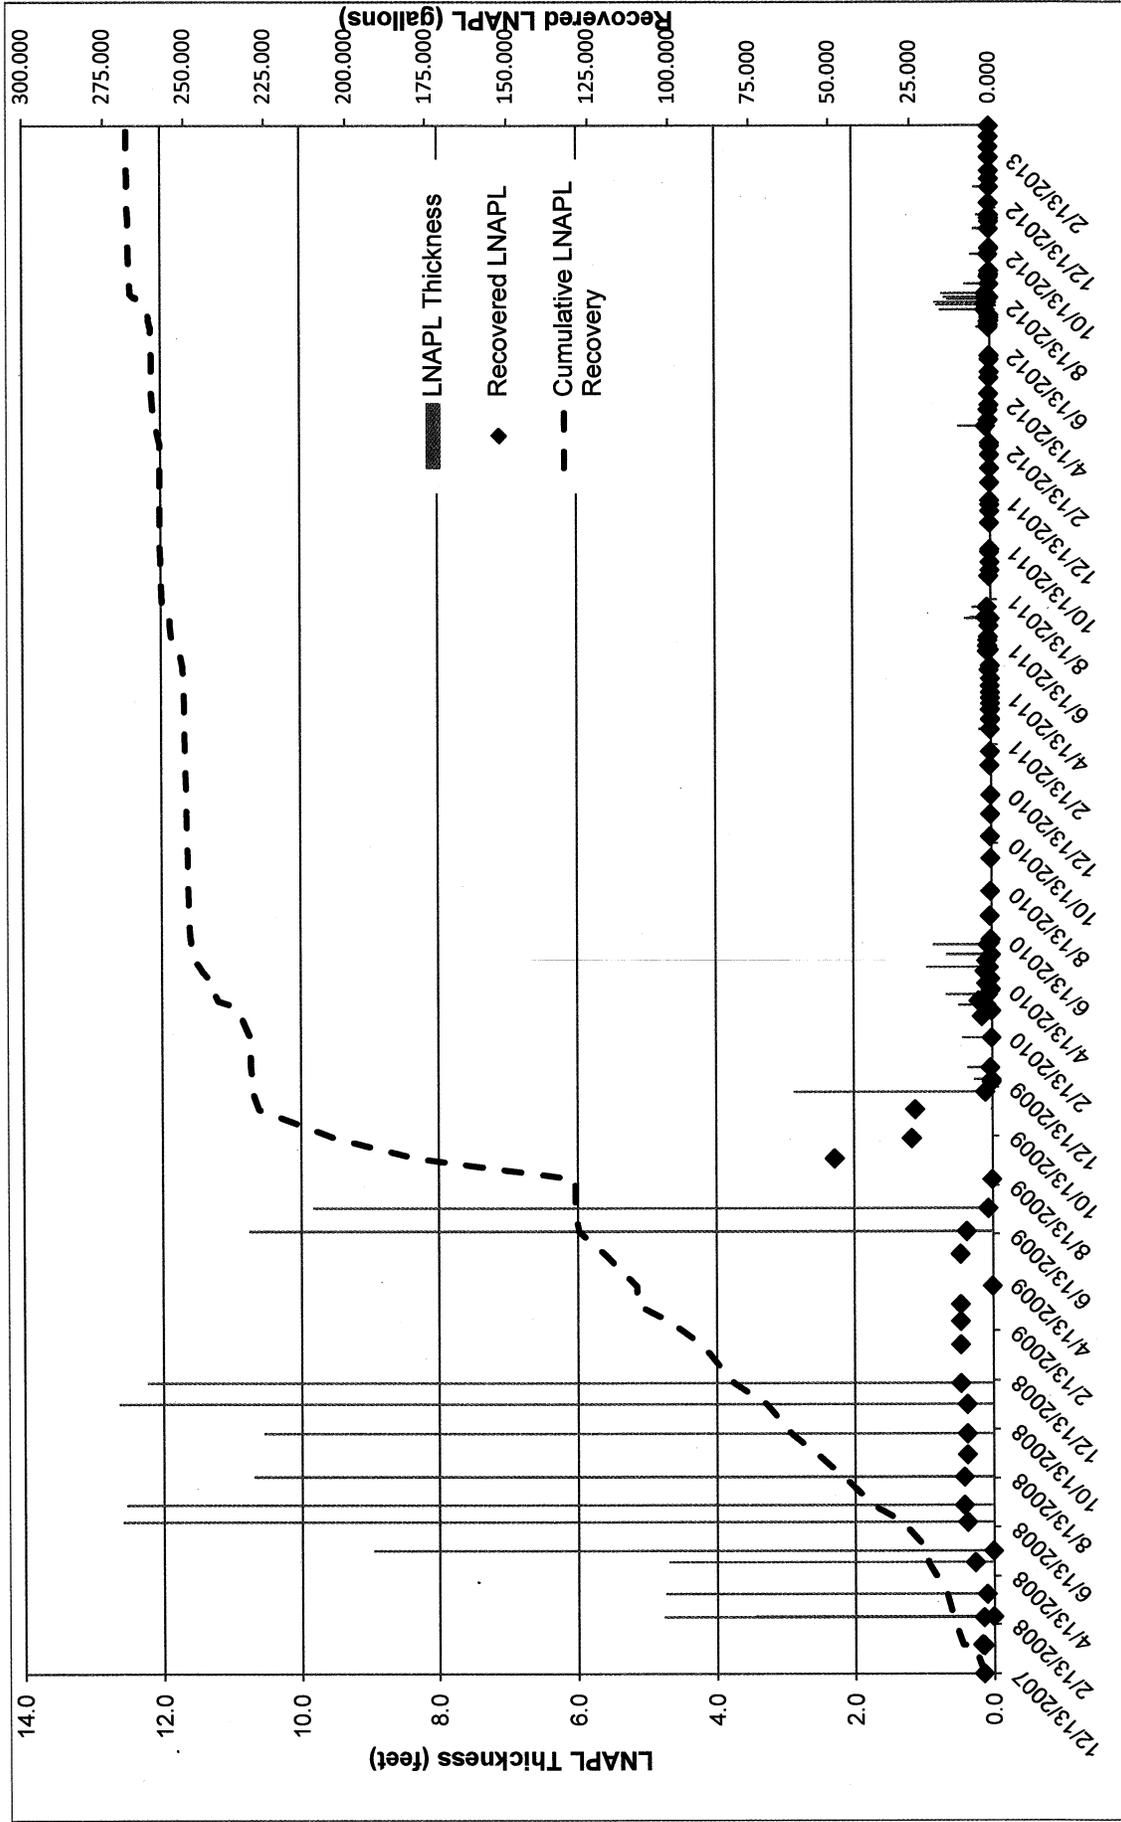
**FIGURE 6. RECOVERED LNAPL AND LNAPL THICKNESS SUMMARY, PA-1
FORMER TEXACO SUNBURST WORKS REFINERY, SUNBURST, MONTANA**

A passive hydrocarbon skimmer is currently installed at monitoring well PA-1. CEMC recovered approximately 0.246 gallons of LNAPL from the passive skimmer unit installed at PA-1 during the first quarter of 2013.

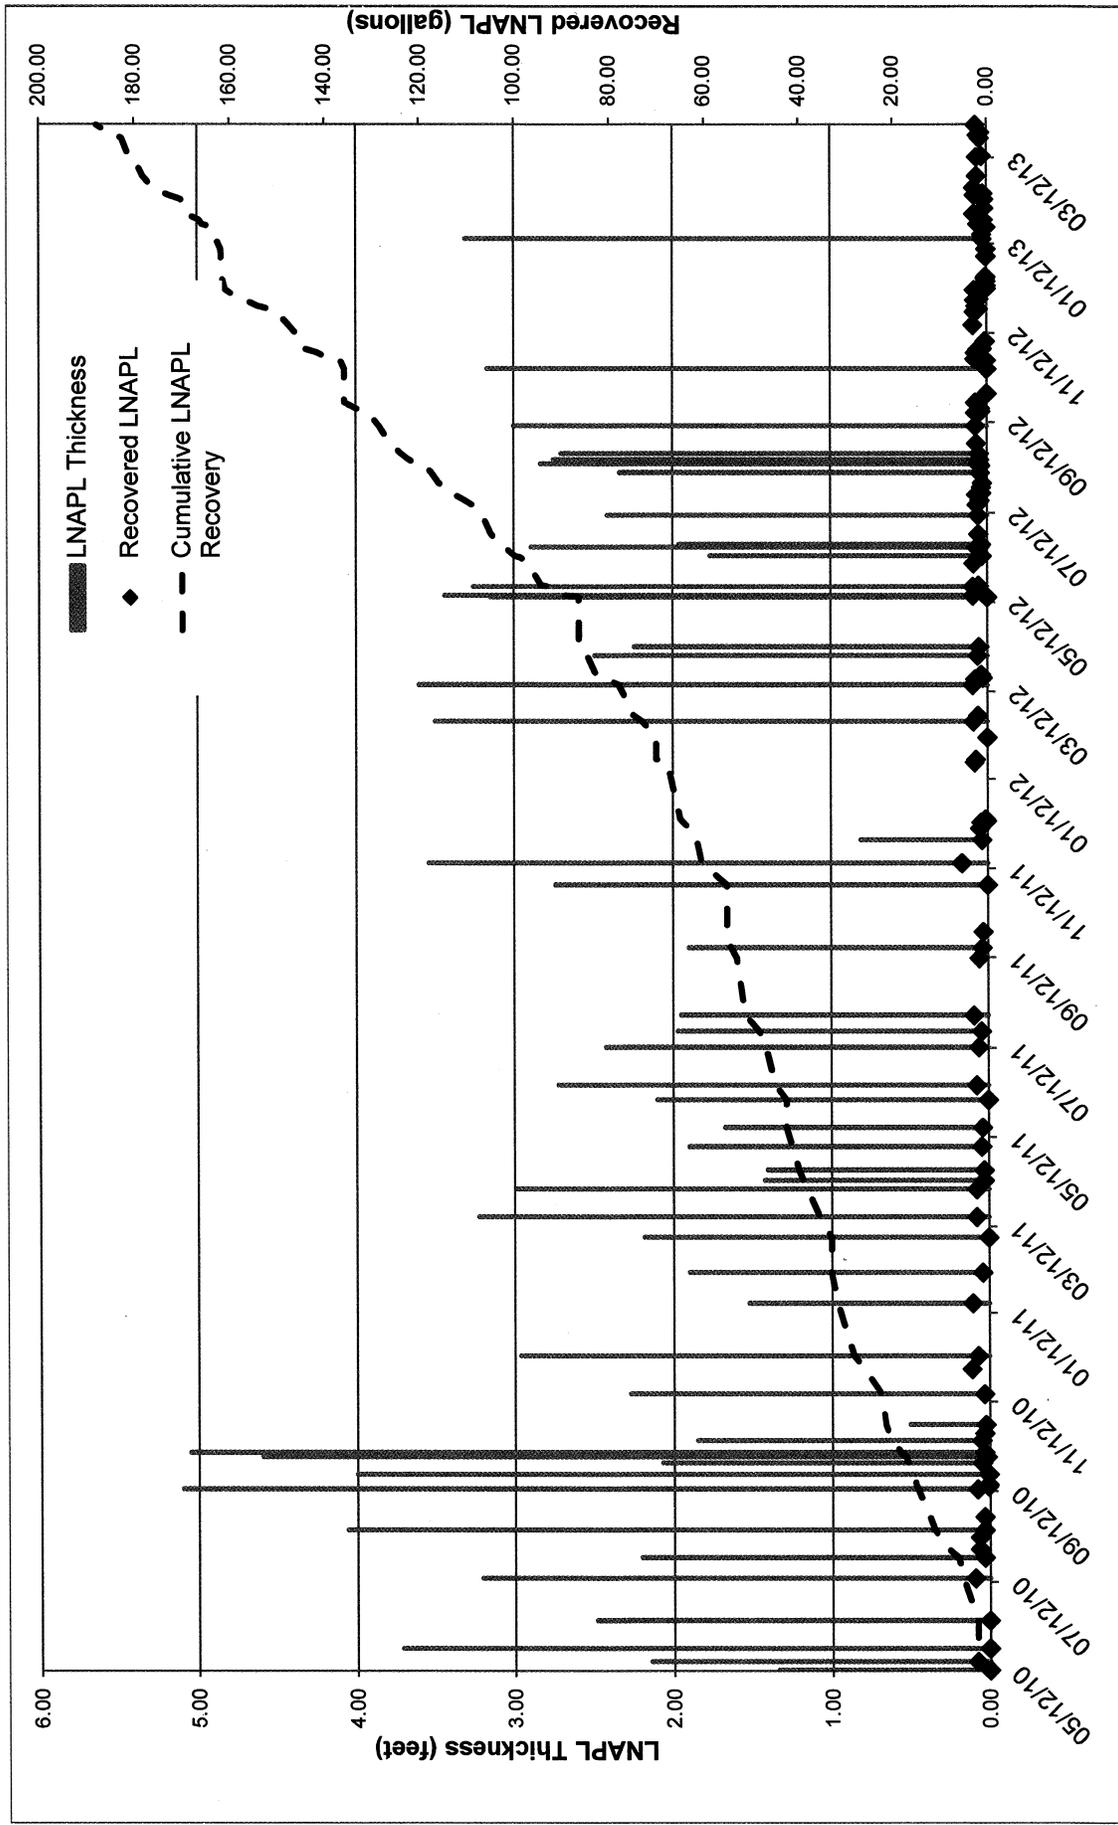
FIGURE 7. RECOVERED LNAPL AND LNAPL THICKNESS SUMMARY, SDW-20D
 FORMER TEXACO SUNBURST WORKS REFINERY, SUNBURST, MONTANA

LNAPL recovery from monitoring well SDW-20D was completed using the *Geotech 1.66 Reclaimer*, as detailed in the Work Plan. Approximately 24.061 gallons of LNAPL were recovered from monitoring well SDW-20D during the first quarter of 2013.

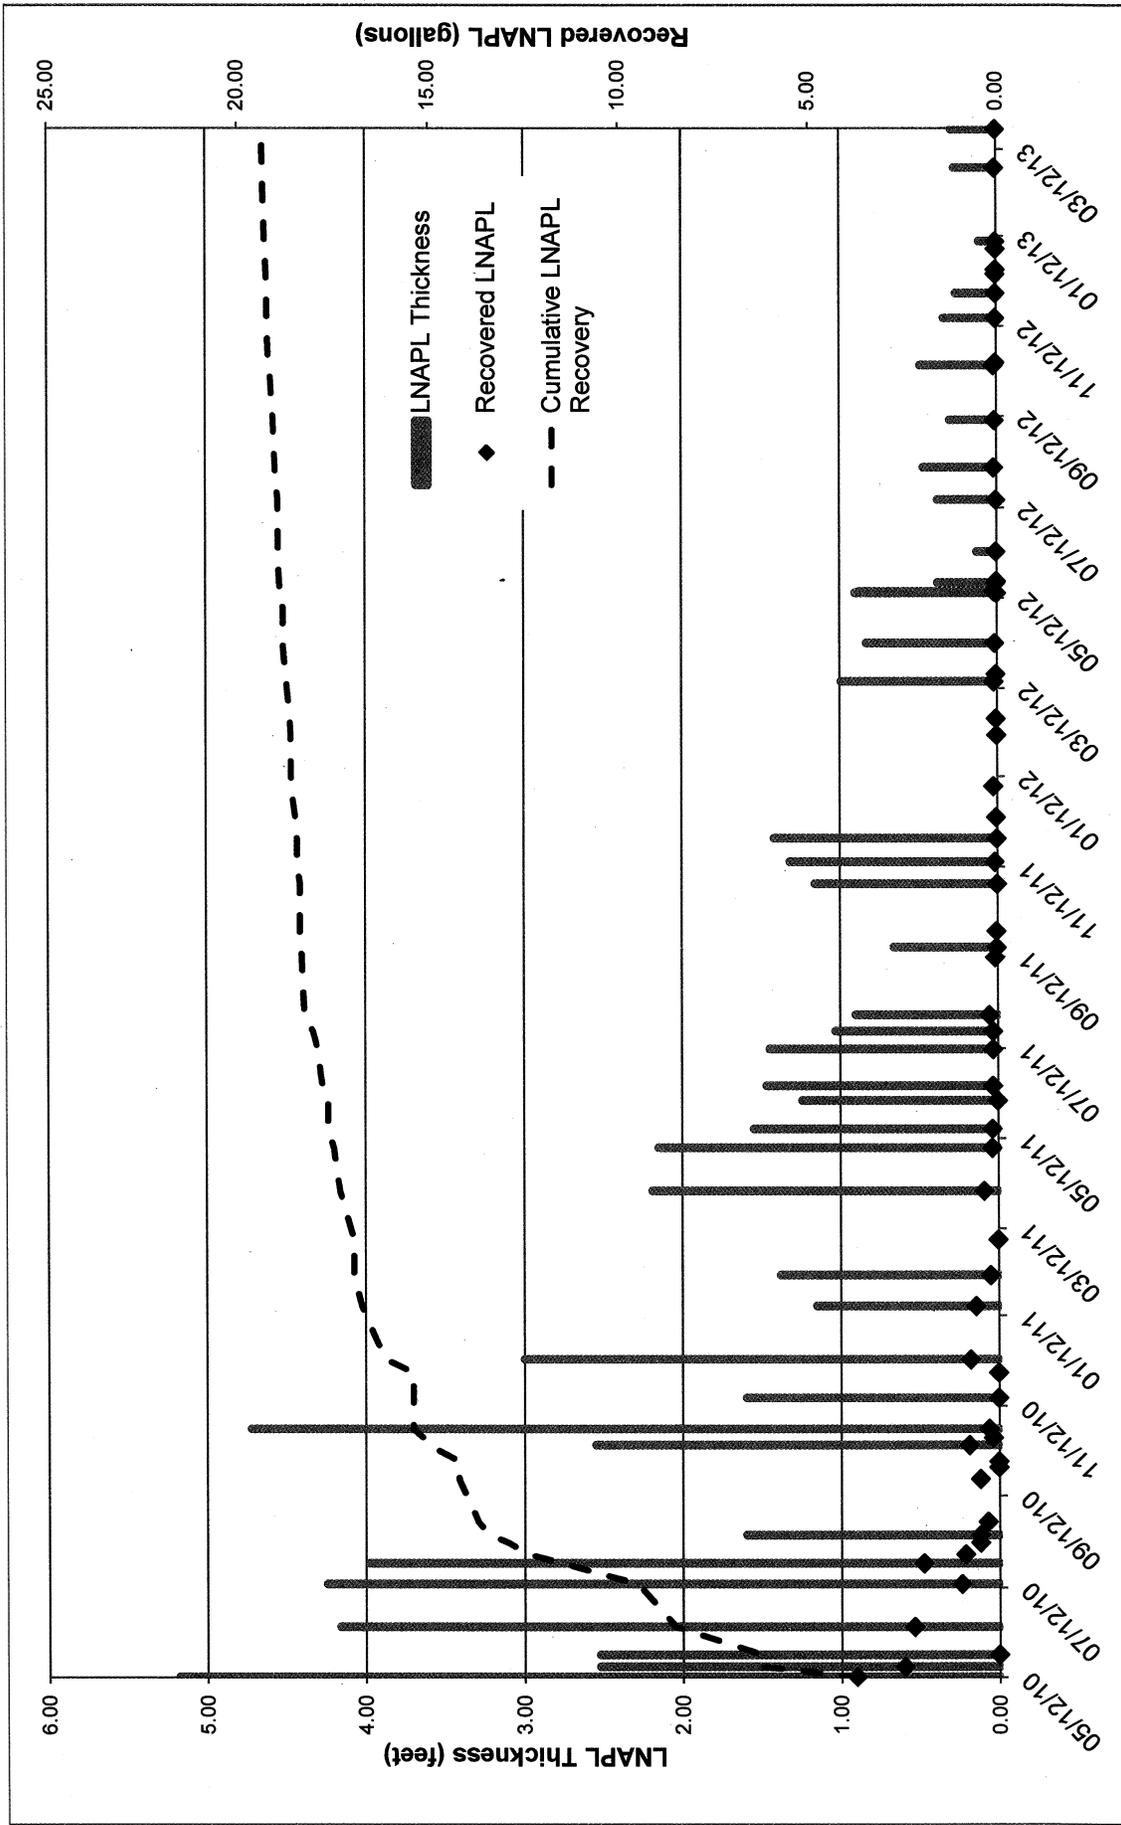
**FIGURE 8. RECOVERED LNAPL AND LNAPL THICKNESS SUMMARY, SDW-24D
FORMER TEXACO SUNBURST WORKS REFINERY, SUNBURST, MONTANA**

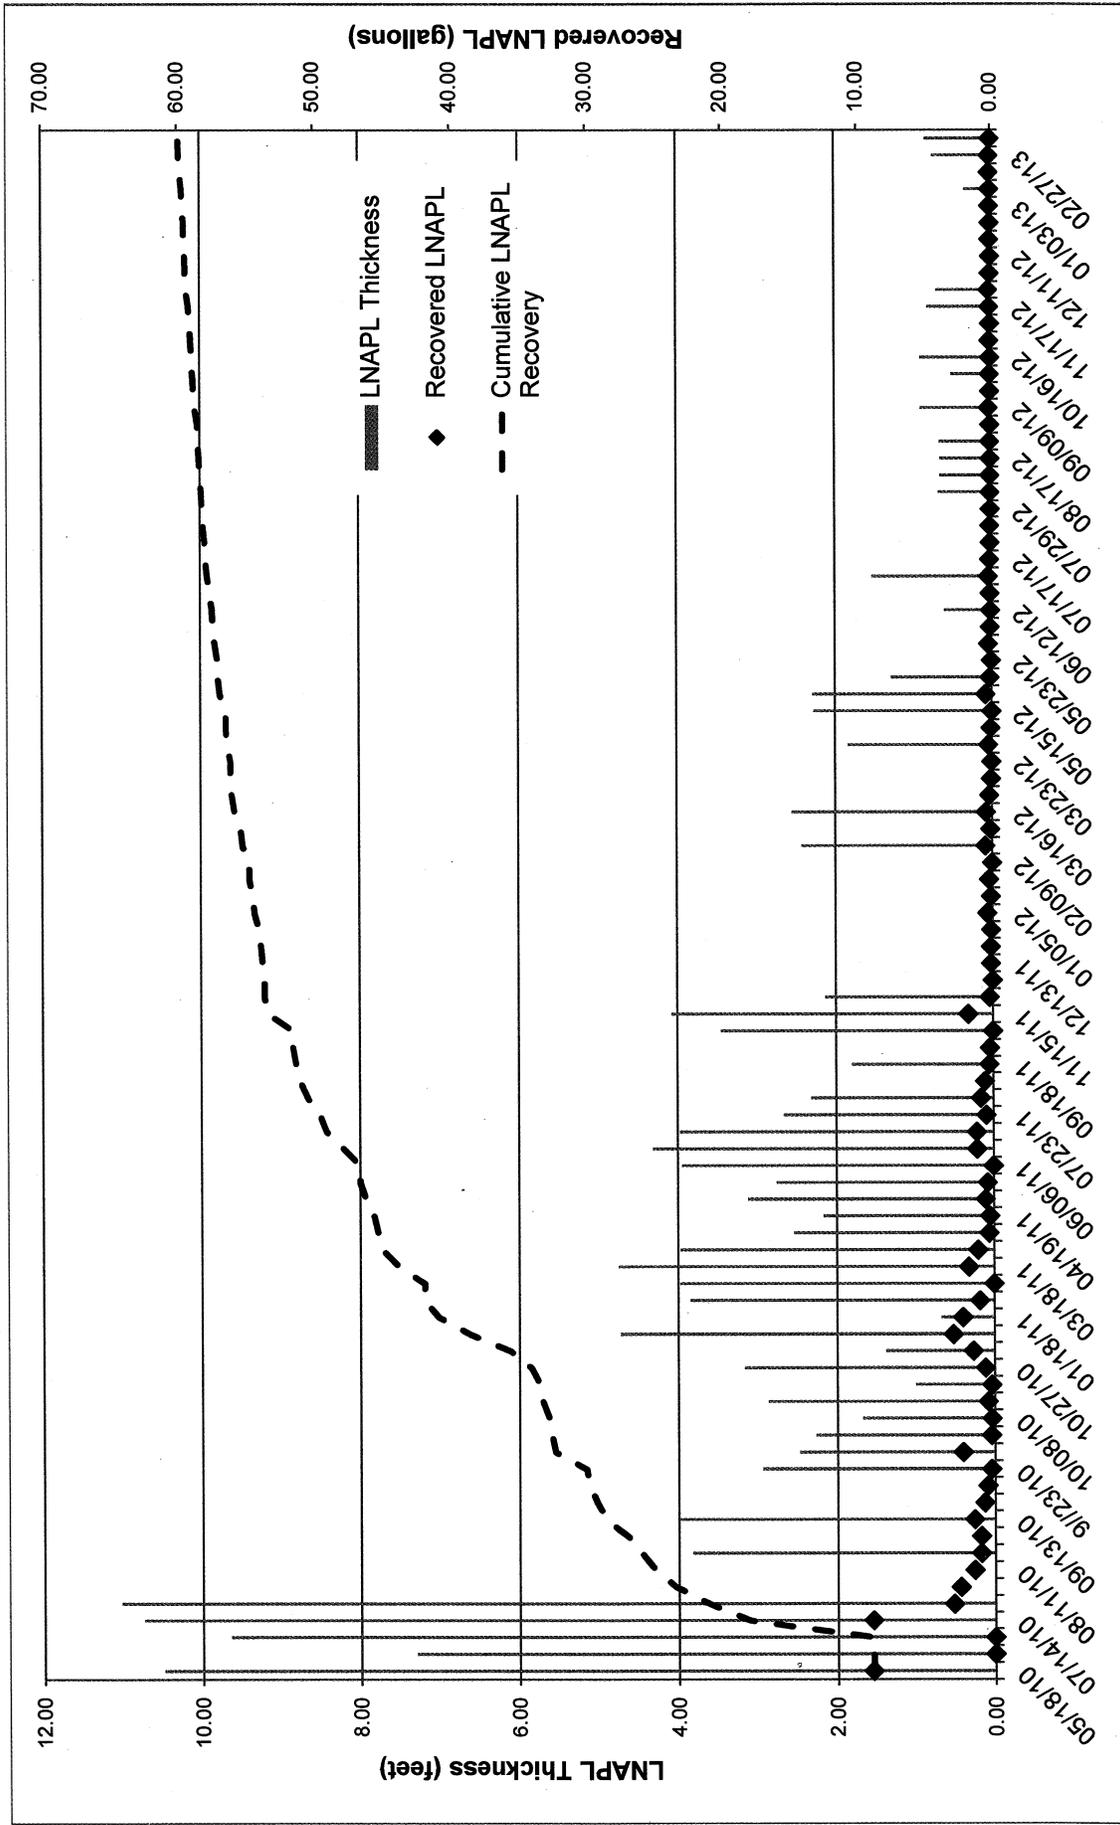
**FIGURE 9. RECOVERED LNAPL AND LNAPL THICKNESS SUMMARY, SDW-31D
FORMER TEXACO SUNBURST WORKS REFINERY, SUNBURST, MONTANA**

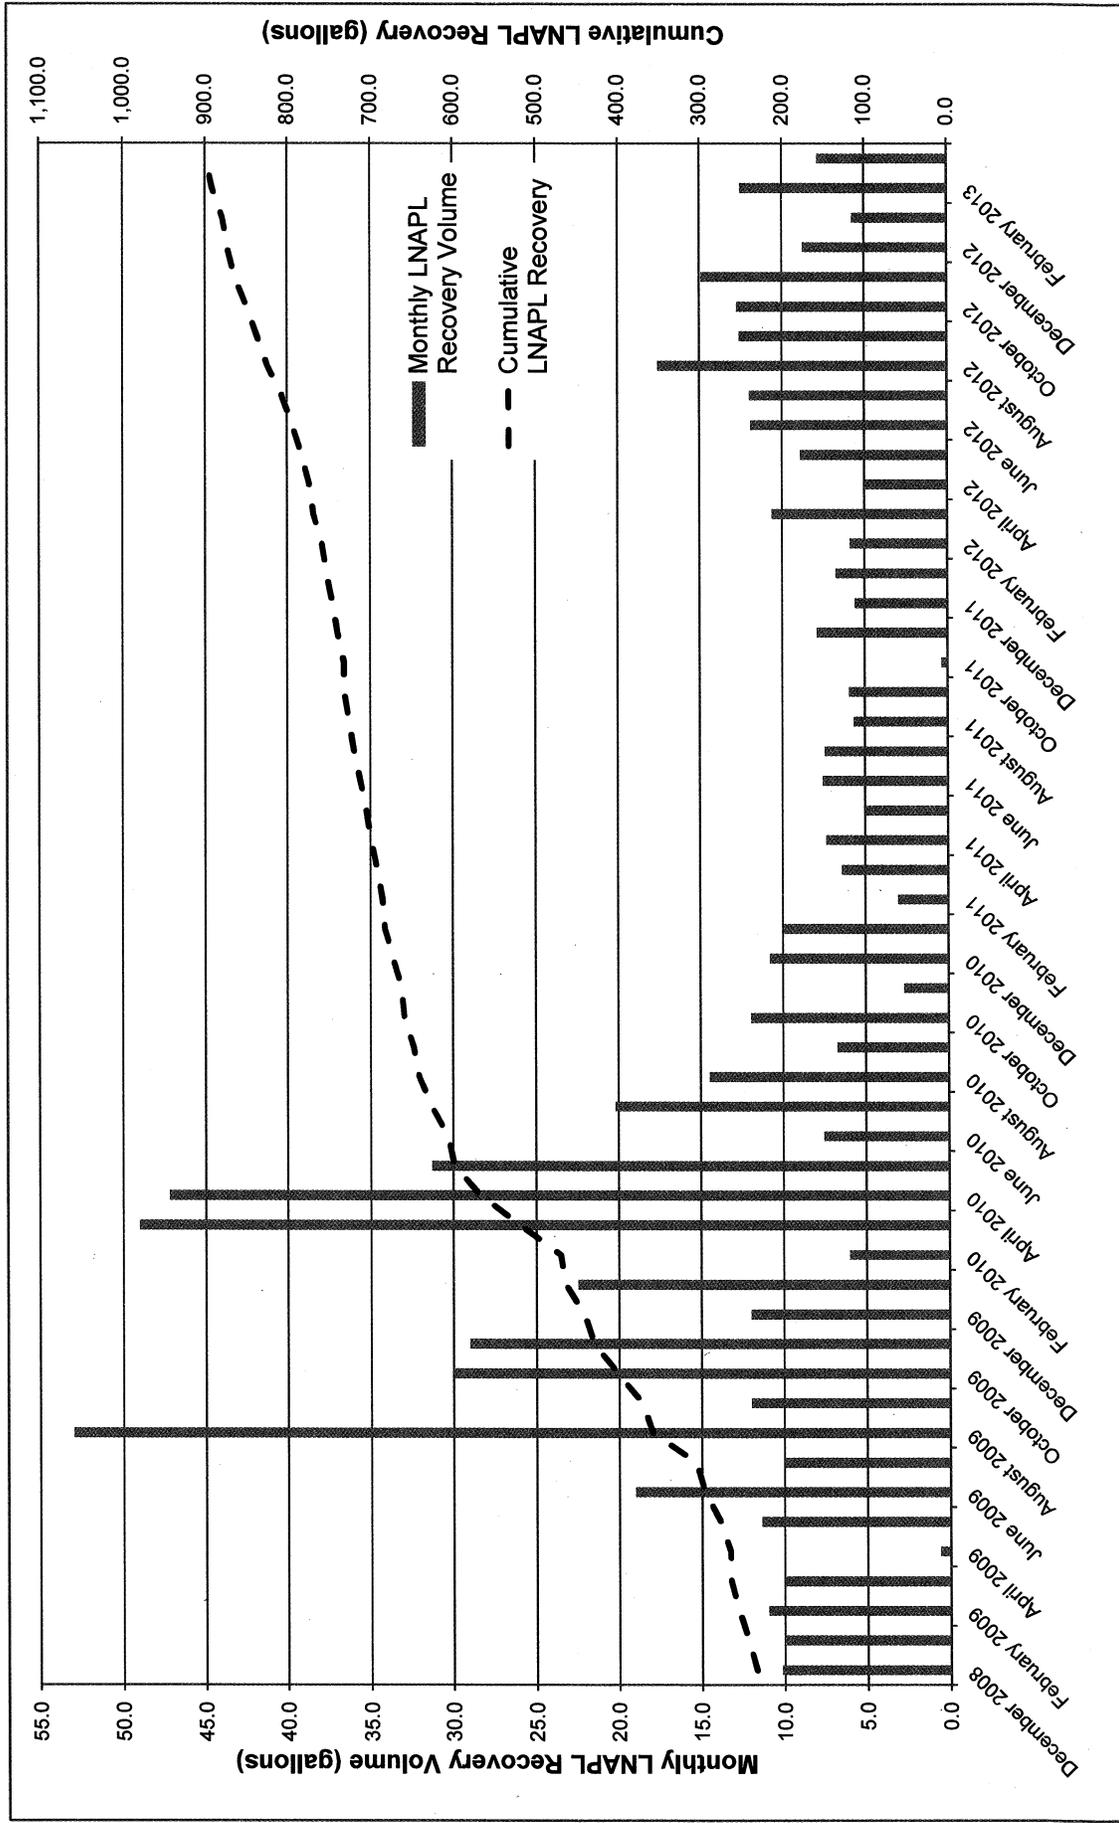
**FIGURE 10. HISTORICAL LNAPL RECOVERY SUMMARY
FORMER TEXACO SUNBURST WORKS REFINERY, SUNBURST, MONTANA**
